# An Archaeological Evaluation of Holly Hayes Farm, Whitwick, Coalville, Leicestershire

Ordnance Survey Grid Reference: SK443154

## SECOND INTERIM REPORT

JULY 2008

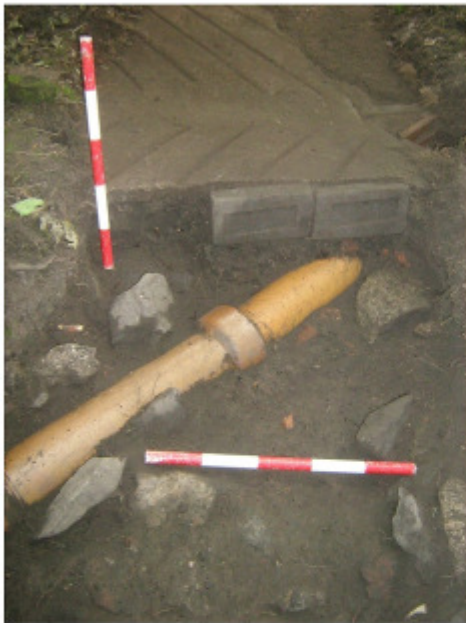
HH COTTAGES T1 DRAIN & APRON JUNE 2008

The trench was extended east by 3.5 metres into the mound. A kerb of bricks delineated a concrete apron which had a pattern of diagonal lines scored into its surface. On its south edge, a square opening to the drain was revealed. This is a rain water drain with the scoring in the concrete apron acting as a run off. Abutting this apron, along an irregular line, a tarmac surface extends east to a concrete base with three square postholes. This is the foundation of a porch. Adjacent to the porch is the stone wall of the cottage with the surviving courses of a red brick doorway. The door threshold was made of dark grey firebricks. Remnants of wood and red painted plaster still adhere to the inside of the doorway. Beyond the threshold, a floor made of red quarry tiles was visible. Beneath the garden soil, a dark brown to light grey sandy loam was present containing numerous fragments / flecks deriving from bricks, floor tile, glass, domestic pottery, coal slack and charcoal. This soil is c.15cms. in depth and lay above the dark orange / light yellow clay subsoil.

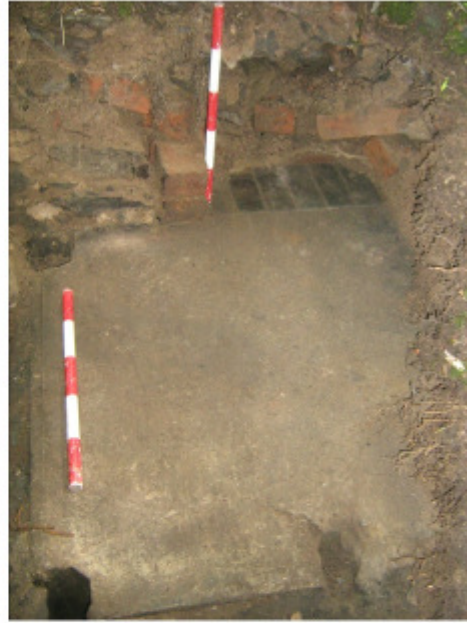
HH COTTAGES T1 WEST DOOR PORCH JUNE 2008
